# Manhole Inspection Summary

Manhole # S39W\_\_007MH

Insp Date: **2/26/08 3:02 PM**

**Location** Address: **rear 1739 covington st.**

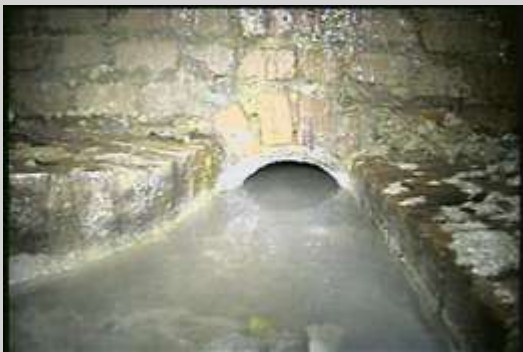
12 O'Clock Outflow

8 in. Circular Gravity Sewer  
Pipe Out @ 12 O'Clock

Infiltration: **None** Pipe Seal Cond: **Unknown**

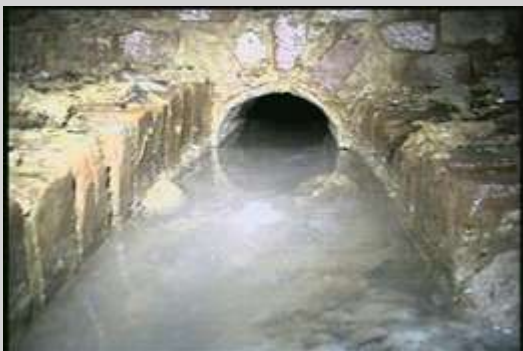
6 O'Clock Inflow

8 in. Circular Gravity Sewer  
Pipe In @ 6 O'Clock

Infiltration: **None** Pipe Seal Cond: **Unknown**

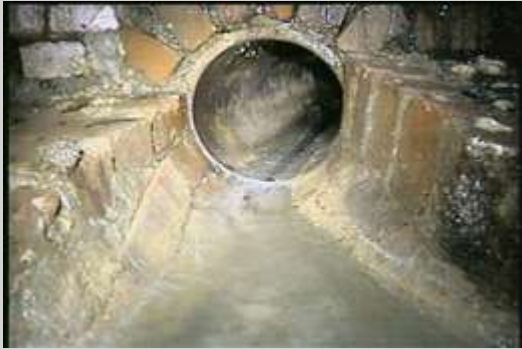
9 O'Clock Inflow

8 in. Circular Gravity Sewer  
Pipe In @ 9 O'Clock

Infiltration: **None** Pipe Seal Cond: **Unknown**
